Monitoring Data Record

Project Title: R-2248BB – Charlotte Outer Loop COE Action ID: 200131321
 Stream Name: UT Thomas Pond (Site 9) DWQ Number: 011231
 City, County and other Location Information: Mecklenburg County, Charlotte Outer Loop, NC 27 Exit (Mount Holly Road)
 Date Construction Completed: April 2005 Monitoring Year: (3) of 5
 Ecoregion: _____ 8 digit HUC unit 03050101
 USGS Quad Name and Coordinates: _____

UT Thomas Pond

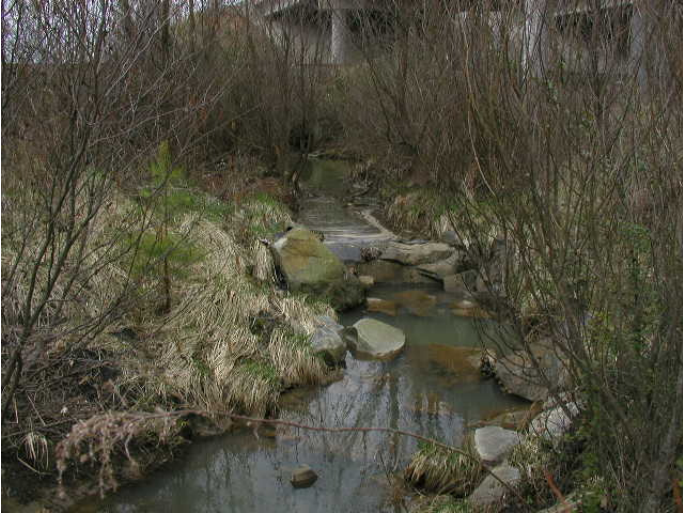
UT Thomas Pond stream relocation is experiencing some instability for the Year 3 Winter evaluation. The crossvane at Sta. 217+80 -L- Photo Point #1 (Upstream) has water piping under the crossvane. A slight headcut is still located at Sta 219+00 -L- which is downstream of Photo Point #3 with no change. Another slight headcut which was noted last time at Sta. 1+00 Loop E, is still located between Photo Point #4 and #5 with no change. There were no grade control structures installed within the sections of stream where these headcuts have formed. These minor headcuts are not affecting the overall stability of the stream. There is evidence that a bankfull event has occurred since the last monitoring evaluation which has caused a divided channel to form. NCDOT will continue to monitor this stream relocation for channel stability and to see if any remedial action is warranted.

Date 3/16/10	Station Number 217+80 -L- (PP#1 Upstream)	Station Number 219+00 -L- (additional photo)	Station Number 1+00 Loop E (additional photo)	Station Number	Station Number
Structure Type	Crossvane				
Is water piping through or around structure?	Water piping under crossvane				
Head cut or down cut present?		Headcut has formed	Headcut has formed		
Bank or scour erosion present?		Station Number 219+00 -L- (additional photo)	Station Number 1+00 Loop E (additional photo)		
Other problems noted?
